## **Deriving the Environmental Problems and Solutions Using Satellite Images Analysis around the Archaeological Mosque of Sultan Al-Zahir Baybars At Cairo, Egypt**

### **Abstract**

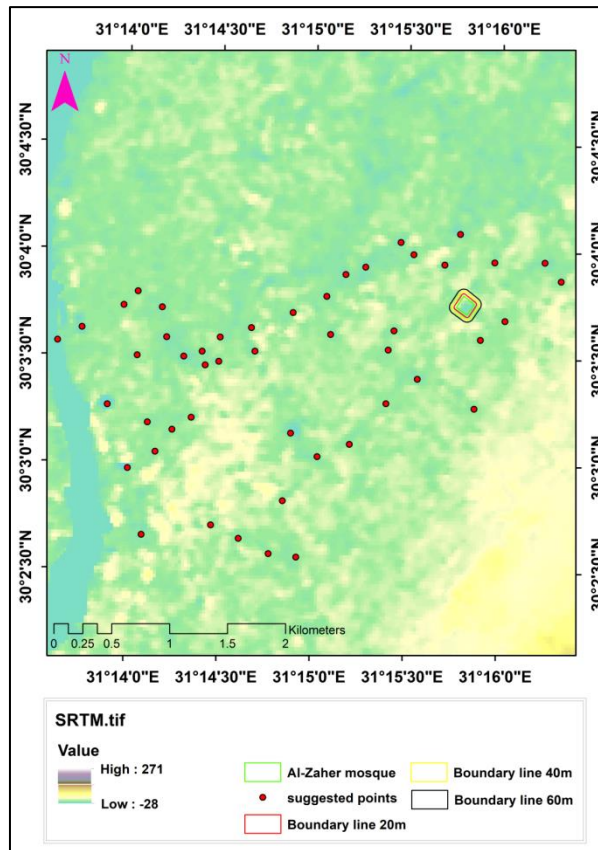
Fig.18 Suggested points for the proposed trenches around the study area.

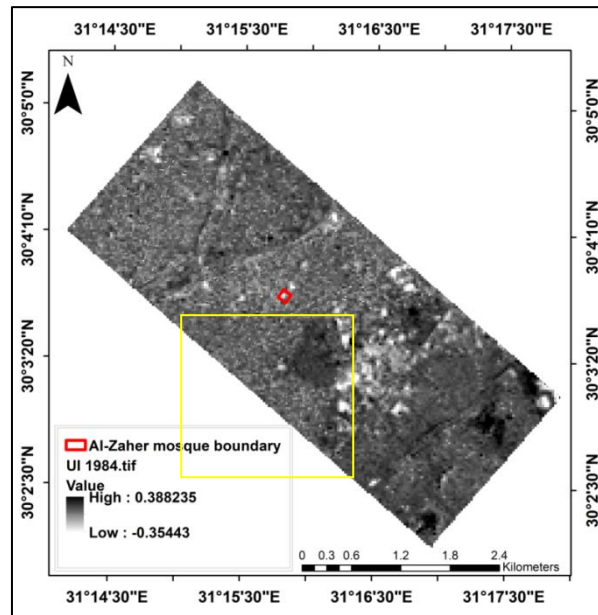
Fig.17 The UI classification for the study area between 1967 (a), and 2017 (b).

On the other hand, the Urban Index (UI) using Landsat TM 1984 and Sentinel 2-A 2017, The expression of the EVI2 equation is presented as follow (Li et al., 2017);

The results in the UI index, indicated that there is a development in urban area. UI value Clearfield that the change in the built-up value from 1984 to 2017 was enormous. These effects are very clear in the built-up around the archaeological area from 1984 and 2017 (Fig. 17a, and b).

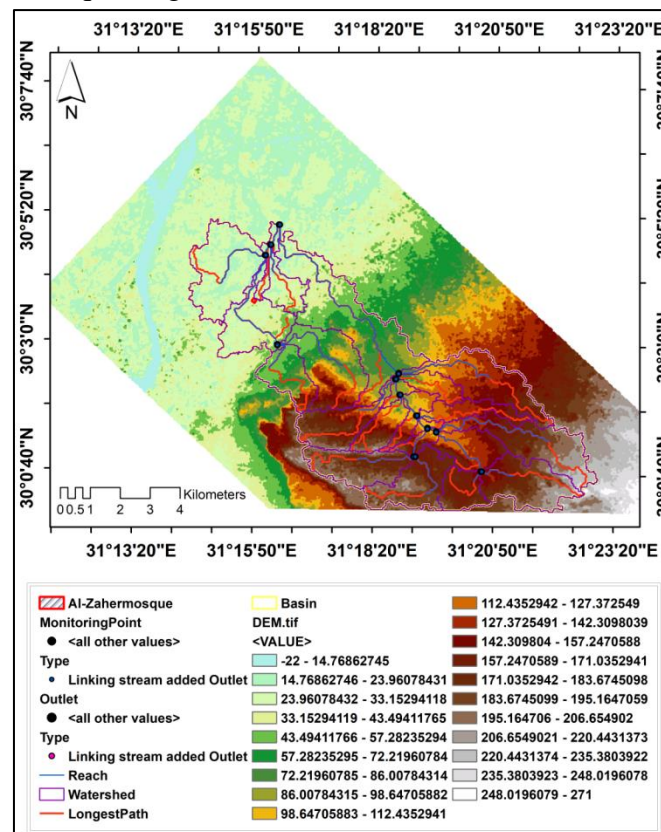
Fig. 10 Watershed delineation by SWAT model and 2D for the study area.

The 2D Elevation model and the watershed has been carried out by SWAT model. The elevations statistics are reported in meters. According to the SRTM Dem and SWAT tool, the mosque is situated between 14m and 23m elevation. It's observed that the direction of the inclination from the southeastern to the northwestern side. Also, the mosque is situated inside a basin, and this situation gave the indicate that one of the reasons of rising the groundwater level in the site of the mosque (Fig. 10).

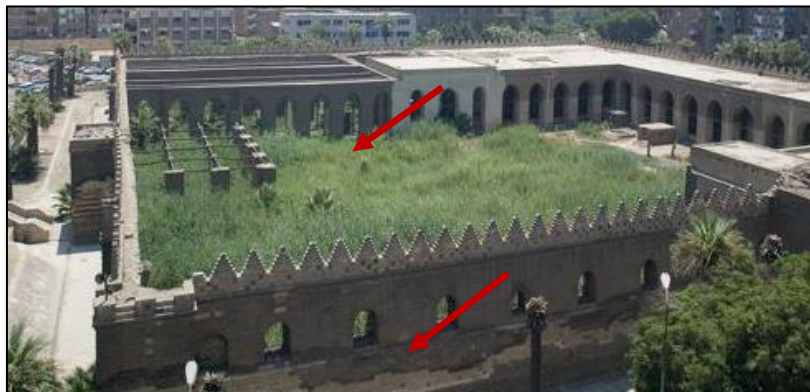
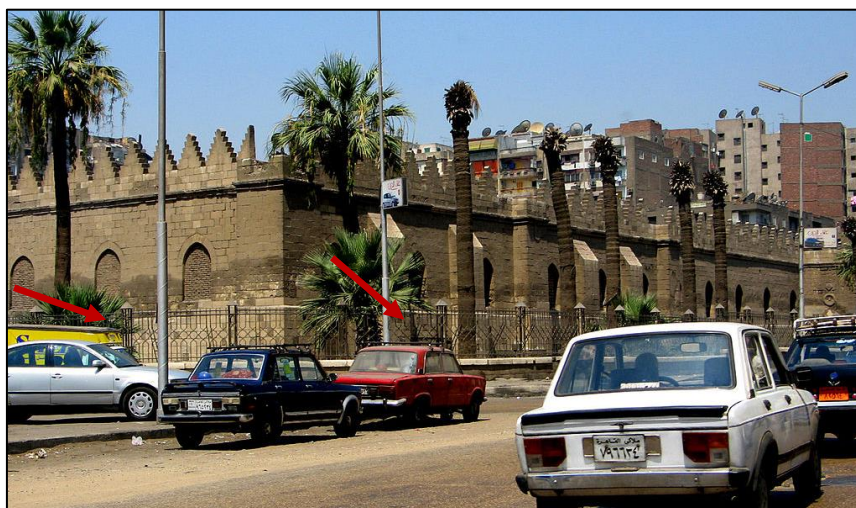
Fig. 8 Vegetation area is spreading interior of the mosque (a), and the deterioration in the Mosque as a result of the rising in the groundwater level through the studied area (b)

Many researchers worked by various methods to protect the archaeological sites in Egypt against the groundwater threats (Elfadaly et al., 2017, 2017, Lasaponara et al., 2015, 2016, Antoniou 1985, Moselhy 1989), threw light on historical background of AL-Fustat city (Hefny 1989, Attalla 1997), which investigated the groundwater problems in Old Cairo (Fig. 6). Besides the problems of the urban sprawling, the eastern part of the study area affected by the rising in the levels of the groundwater, this indicates that the recharge rate is high than the discharge of the Nile River. The highest levels of groundwater are in the Eastern part of great Cairo, as in Abbasia district, the levels of groundwater and that of the River Nile are affected by each other, especially after the building of the high dam (Zaghloul and Elbeih 2014) (Fig. 7a, and b). Urban encroachments, the geological, and hydrological setting have a great role in the archaeological damage (Fig 8a, and b).

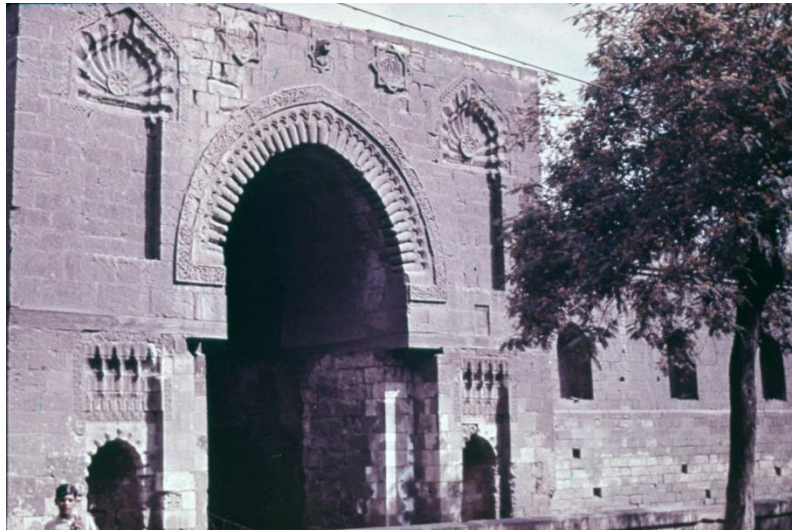
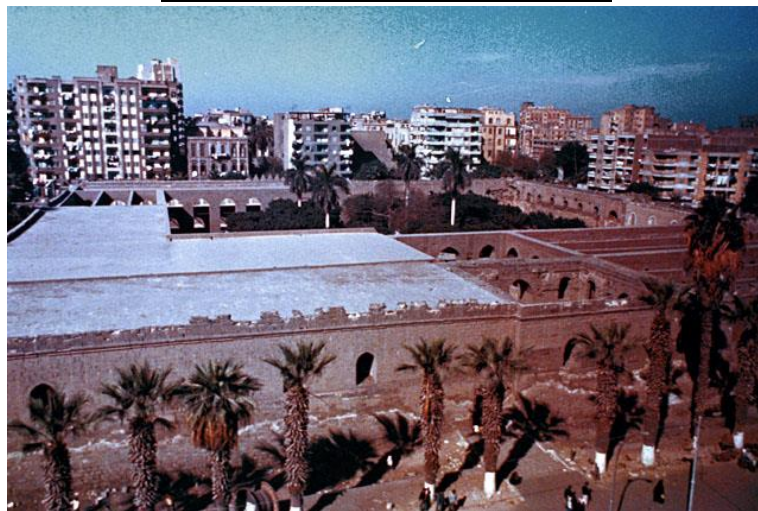
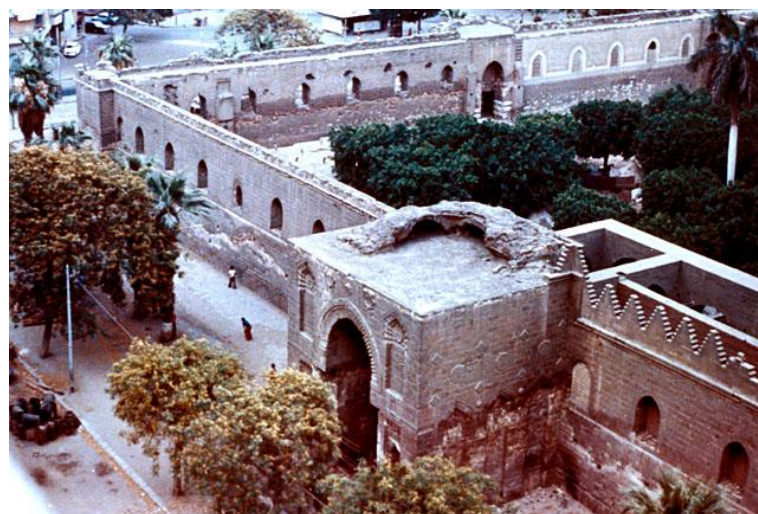
Fig.3 Some of the architectural elements of Al-Zahir Baybars mosque (a, b, c, and d).

western tower which is stuffed with a drawer reaching up to roof of the mosque. The architect has used several shoulders for buttressing the west-southern and east-northern walls extending from the Qibla's portico. These shoulders are based on the beads of an arch that constitute such portico. The higher distance higher above the walls are ornamented with seventy-two windows at around eighteen windows for each front; these windows take the form of arches that are framed with Kofi-styled Koranic verses; as regards the windows themselves, they are shielded with geometric decorations (Fernandes 1987). At the center of the mosque there lies an open court yard and square in area; it is surrounded by four portico, the most important of which is the Qibla's portico; it consists of nine arcades with arches based on column and pier. At the center of the Qibla's portico in front of prayer nich, there lie a square Maqsurah, it is surrounded by eight piers with their corners engaged columns, This Maqsurah was covered with a large dome (currently not available, and described by Al-Maqrizi to be as big as that of Imam Shafiae, and it must have been made of wood). At the front of the southern side of the Maqsurah's niche a semi-circular cavity that is portable by a pair of columns; such a niche is void of ornamentation, and it must have been covered in a layer of colored marble as there lies above the niche a white marble slab upon which there exist a foundational text of four lines; within the text the establishment year is mentioned as 666 A.H/1268 A.D. Notably, the Qibla's portico is composed of four arcades with arches carried over marble columns whereas the arches overlooking the court yard are carried over pier built with red brick attired with stucco; and also there exists a transept composed of three Aisle and their arcades start with a perpendicular from the court yard to the niche's walls (Parker et al., 1985). The two side porticoes comprise three arcades whose arches are perpendicular at the niche's walls. These porticoes are a transept at the two side entries as parallel to the walls of the niche. As for the west-northern portico, it is composed of two arcades with arches that are posed in parallel with the niche's walls whereas these two arcades are a transept at their center right in front of the entrance where a columnar post appears. It is noticed that all the internal piers have disappeared except for the piers of Maqsurah; and it can be observed from the arches' shapes that the buttresses were supported with wooden joints. There is no more trace of any ceilings of this mosque although its overall planning foretells of wooden ceilings which were golden and colorful (Vermeulen and D'hulster 2010) (Fig. 3a, b, c, and d).

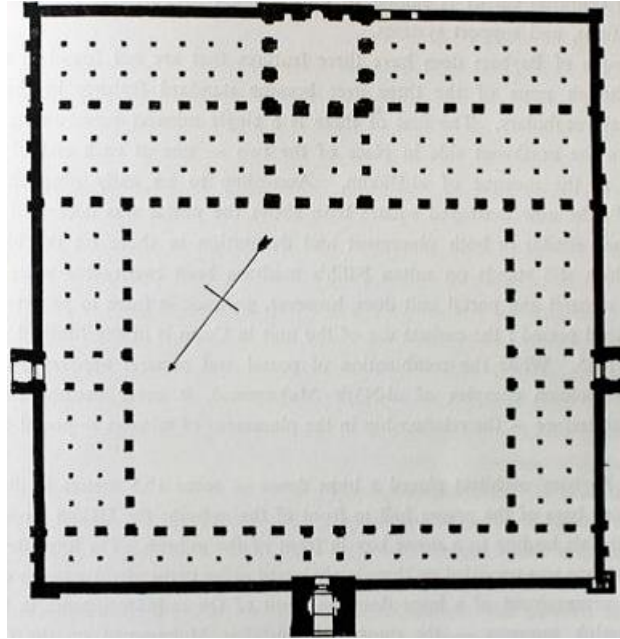
Fig.2 Mosque of Baybars al-Bunduqdari planned. <https://mennaelmahy.wordpress.com/egypt/jami-al-sultan-al-zahir-baybars-al-bunduqdari/>
