Heliopolis as a Heritage area, The Revitalization case study

More important questions are raised regarding the regeneration of Al-Korba, the case study that addresses the governmental attempt in Heliopolis recently.

The case study of this paper is one of the Heritage listed buildings in Heliopolis.

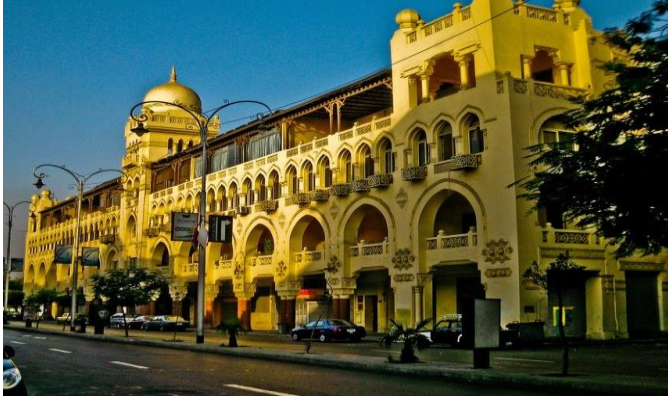
The main problem of *El-korba* buildings is that people left them and moved to new cities out of Cairo, and because of the very low cost of rent, they kept it closed instead to leave them to other people, and because of that, there are no maintenance for the closed apartments which caused different damages to the buildings, also the people who is still living there closed the balconies to have more internal spaces, even one of them built a swimming pool in the balcony without isolating the floors which resulted in huge damages to the concrete floor, adding to that putting the air conditions on the facades which resulted damages to the decoration and plasters because of water that coming out from air conditions, also there were more than 24 families living in the workers rooms on the roof of the building, and they all using only one bathroom, throwing their rubbish on the roof of these rooms. Another problem

Fig (6) a façade in Heliopolis covered by air conditions, wires and advertisements also closed balconies by residents.

The first step was the most difficult one, as it was how to convince the residents of the buildings to remove the added parts and to remove the air-conditions that distort the facades

It was the first step in the work site, we removed all the added buildings to the original buildings, air-conditions satellite dishes, advertising banners and wires were removed from the exterior facades, also we removed all the wood and metal that were closing the balconies

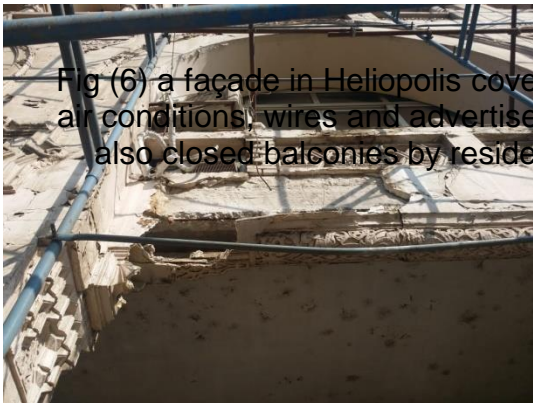
was the over paintings, because the buildings are in front of the presidential palace, so they were painted every while with different colors to look cleaned. Also the residents of the buildings did not care about making gutters to drain rain water and didn't care about Sewer pipes which led to damage to the decorations and plaster.

Fig (7) deteriorated stucco by water comes out from air conditions

The cornices, stucco decorations and plasters were highly damaged, and many parts were missed, so the missed parts were integrated by a mortar contains:

1 white cement : 3 gypsum : 10% Addibond 65 from CMB, and before putting the mortars, the walls were cleaned so well by water to eliminate any dust, after that were painted by a solution of 10% Addibond 65 to improve the connection between the new mortars and old mortars.

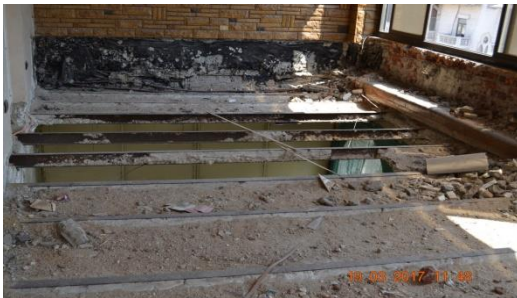
Fig (8) destroyed concrete ceiling because of transferring the balcony to swimming pool without isolating the floors

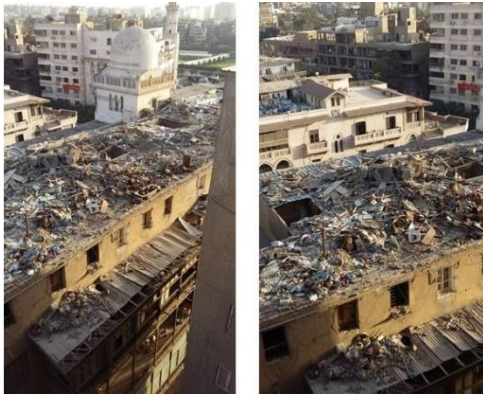
Fig (10) the buildings' roof covered by rubbish

The Heritage building must be restored and maintained continuously to avoid the irreversible damages that could be happen. The main problem here, were by people who are living on the roof, they arrived to 120 small rooms, every room had a family, and ignorance of the value of the buildings, they didn't care even about cleaning the roof, then the air pollution had effected the surface of the facades.

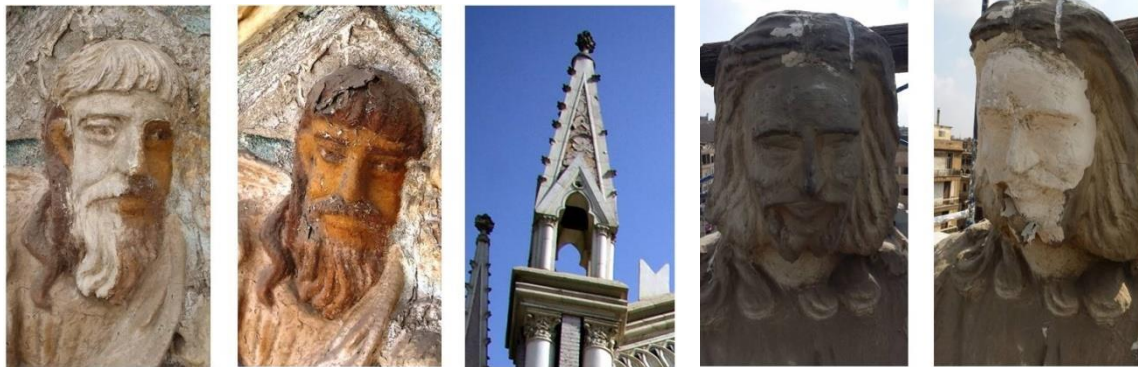
Fig (12) overprinting's layers by oil colors at Maronite Church

Fig (13) Black hard crust on a face of statue at Maronite Church

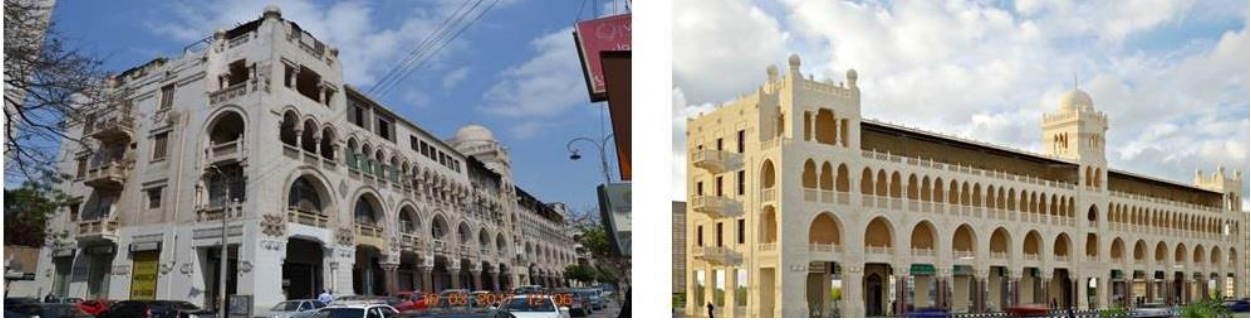
of the buildings, some of them agreed immediately when they saw the 3D design to the buildings after restoration, the others agreed one by one when they saw the result after the beginning of work.

Fig (14) 3D proposal for the building after restoration, AutoCAD 2016.

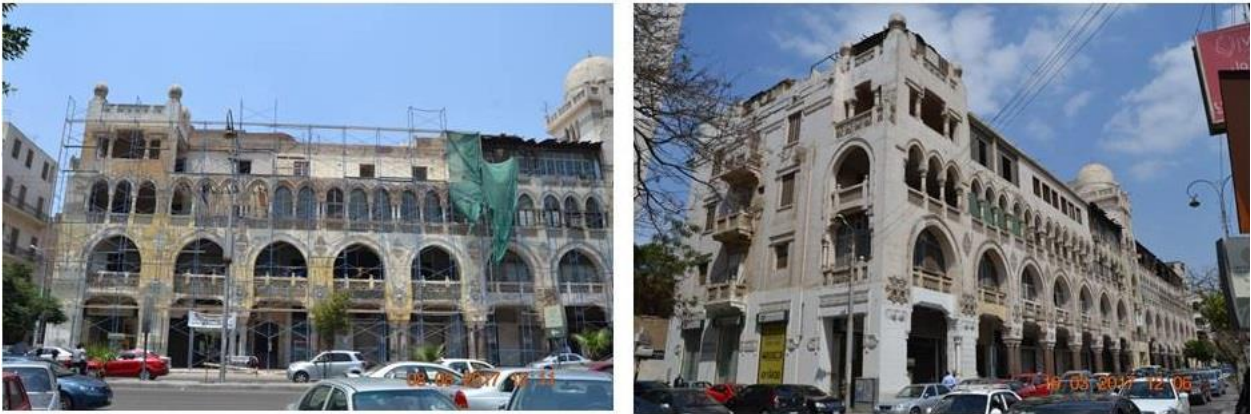
Fig (15) Removing the added parts to the original building

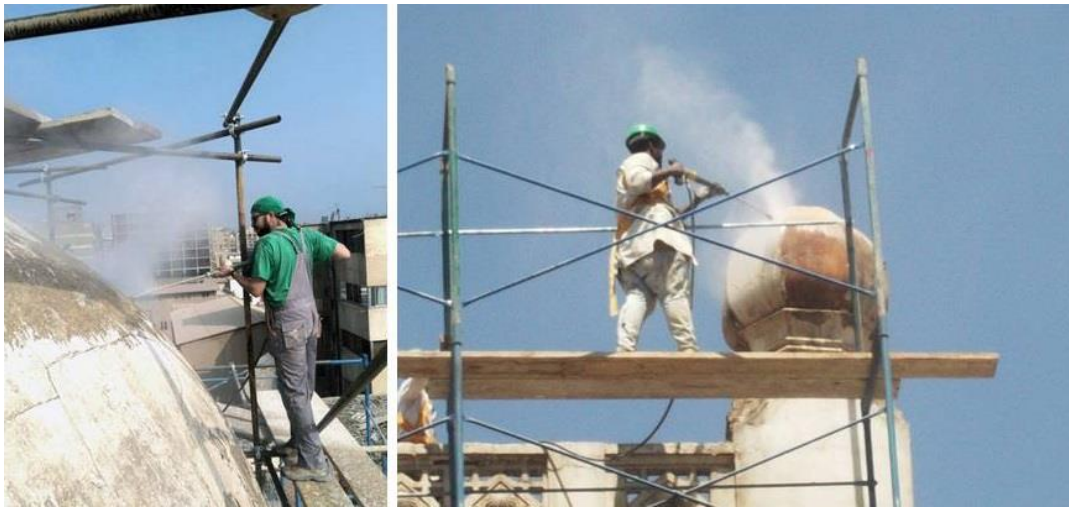
Steam cleaners can broadly be divided into small industrial/domestic units and the larger machines (such as Doff and ThermaTech) that are commonly encountered in building conservation. Steam cleaning system was used for cleaning the façade, one of the best benefits of steam cleaning is that it eliminates these nasty elements from facades, and when steam penetrates surface pores, it removes dirt, debris, bacteria, and other tiny elements with hot vapor molecules, adding that steam remove the layers of over paintings easily.

As the buildings' location is in front of the presidential palace, so they were painted every while to be shown clean to the visitors of the presidential palace, so the steamer was useful to remove all over paintings without any damage to the original plasters and decorations.

Fig (16) cleaning by steamer to remove the over paintings.

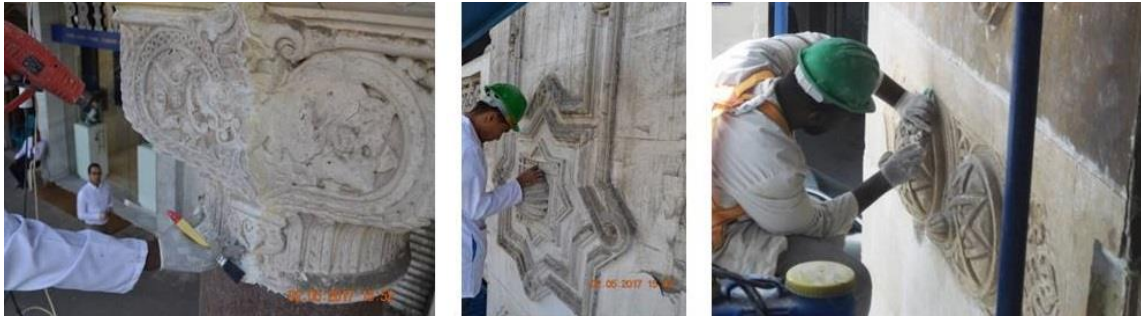
After steam cleaning, some solid dust and cement on the surface couldn't be removed by steam, so metal tools were used to remove them by mechanical cleaning without any liquids.

Fig (17) Mechanical Cleaning by using metal tools to clean the solid dirty that steamer couldn't remove it
Integration injection and consolidation:

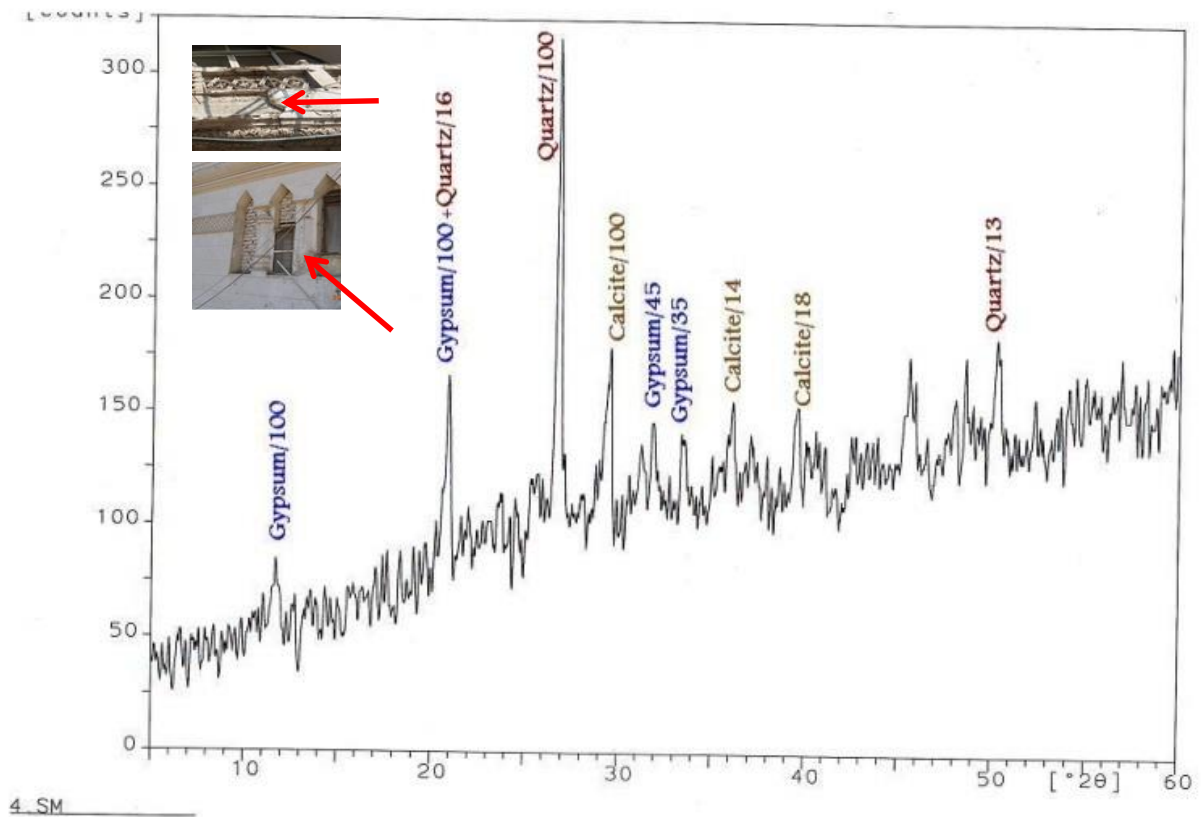
X-ray diffraction analysis (XRD) was done to different parts of the original plasters, and from these analysis found the composition of the mortar was sand, gypsum and calcite.

Fig (18) result of XRD to a sample of plaster mortar

N	Scientific Name	Chemical Composition	Chemical Formula	Reference Pattern	Percentage %
1	Quartz	Silicon Oxide	SiO ₂	46-1045	76
2	Calcite	Calcium Carbonate	CaCO ₃	05-0586	16
3	Gypsum	Calcium Sulfate Hydrate	CaSO ₄ .2H ₂ O	33-0311	12

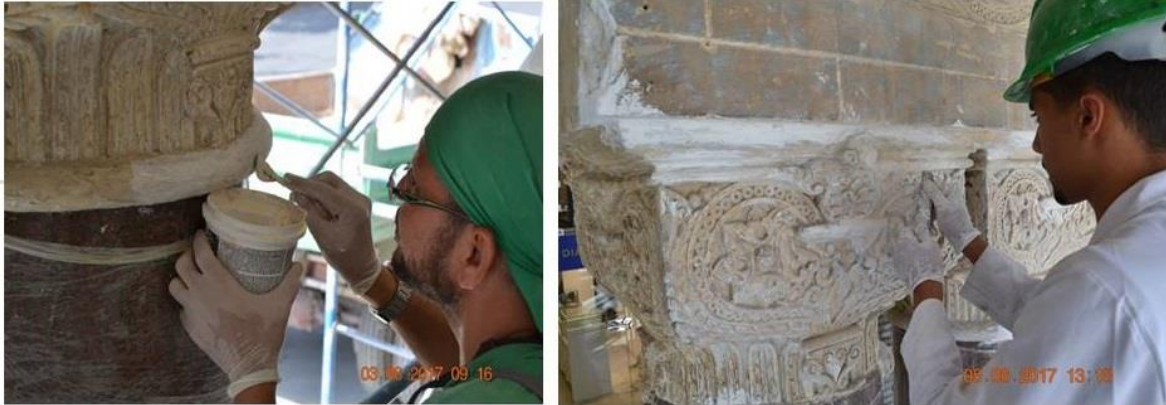
Fig (20) Integration of the missed parts of stucco decorations

The big cracks in plasters were injected by a mortar consisting of white cement 1 : lime 1: 20% acrylic Acril 33 for the Italian company CTS, and this was after injection with water and alcohol to clean the dust inside the cracks.

The small cracks were injected by Acril 33 20%.

Also the voids behind the stucco decorations were injected by the same composition.

After that all the plasters and stucco cornices were painted by a solution 20% of Acril 33 for consolidation.

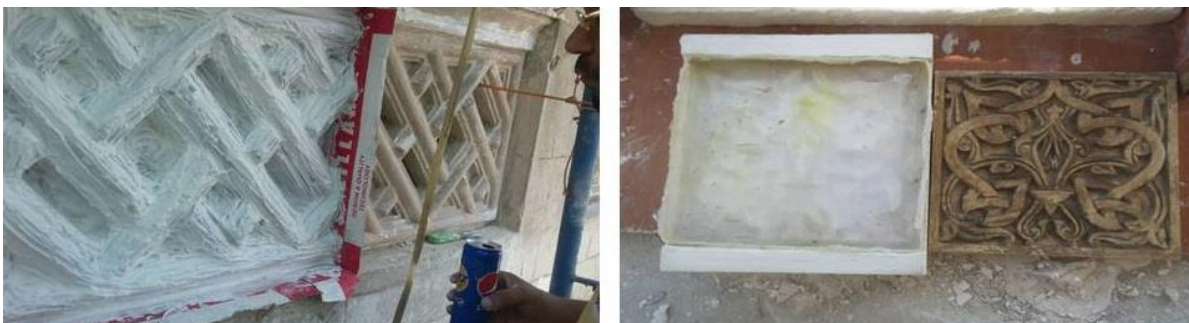
Different types of molds were made to have copies of the different lost decorations, as polyester molds for the different sizes of BABAWAT, silicon molds were used where there more decorations, which it has more details.

Fig (22) Silicon casting molds were made to parts that have fine decorations

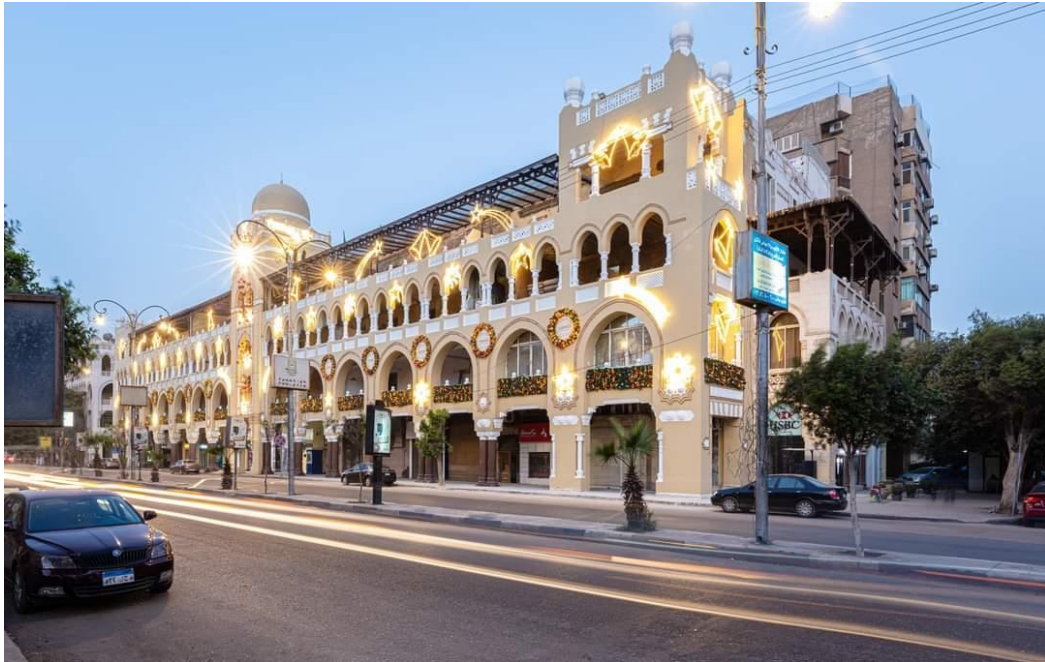
After steam cleaning, we could get the original colors of the painting, and after many trails we could arrive to the colors degrees.

Fig (23) the front facade after restoration

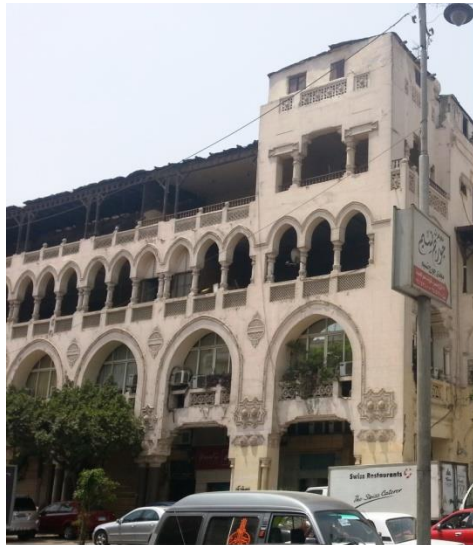
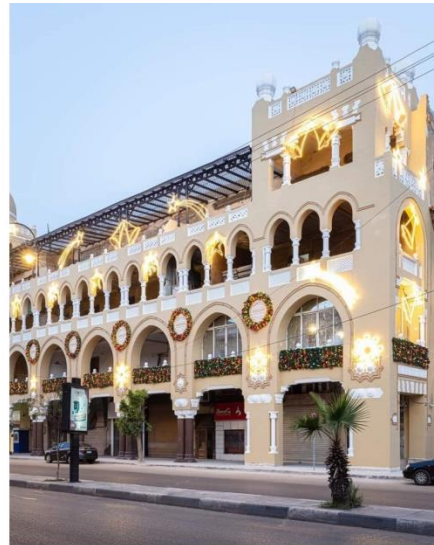
Before restoration

After restoration

Fig (24) the front facade restoration

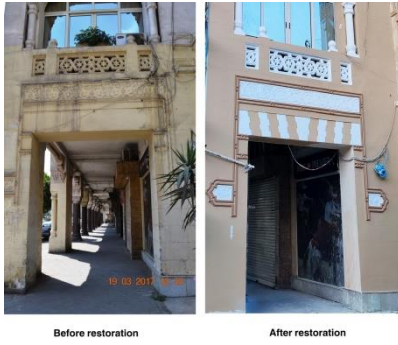
Fig (25) the corridor After restoration

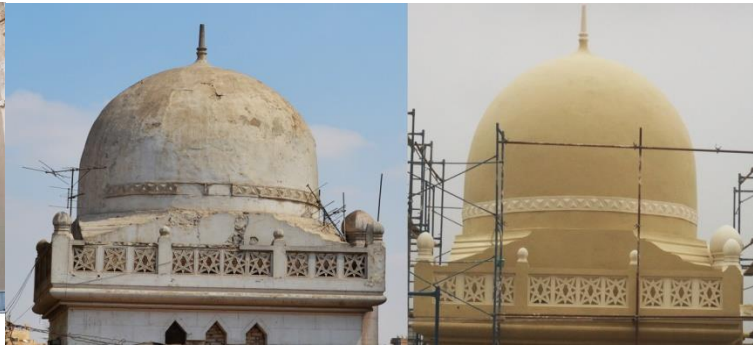
Fig (26) The dome after restoration

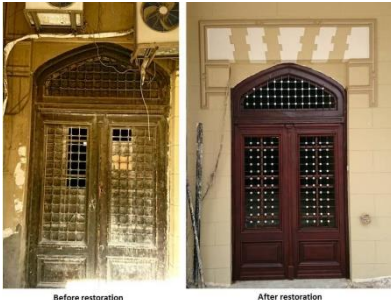
Fig (27) the door after restoration

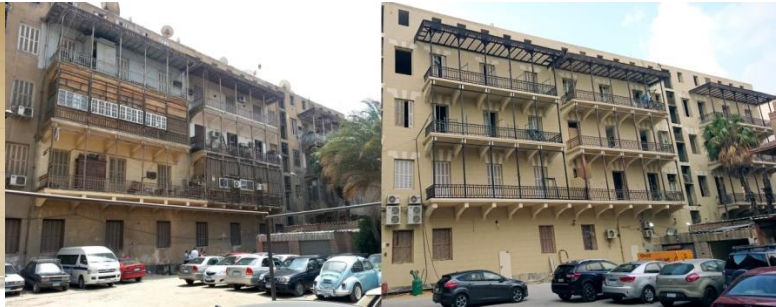
Fig (28) the back facade after restoration

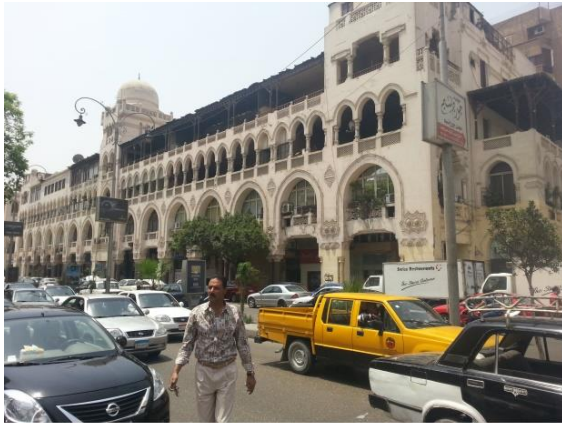
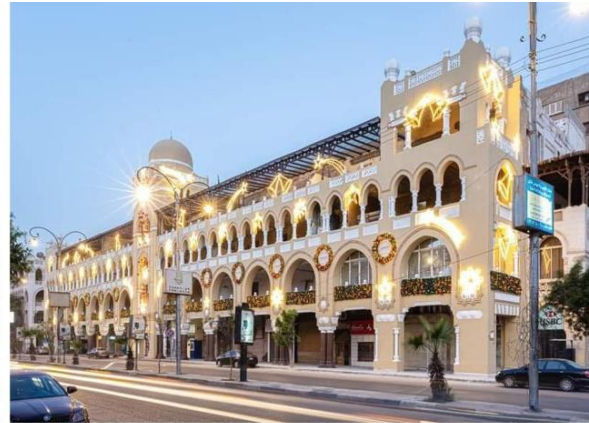
Before restoration

After restoration

Fig (24) the main façade after restoration
