An experimental study for evaluating the efficiency of consolidated materials for limestone treatment.

Abstract:

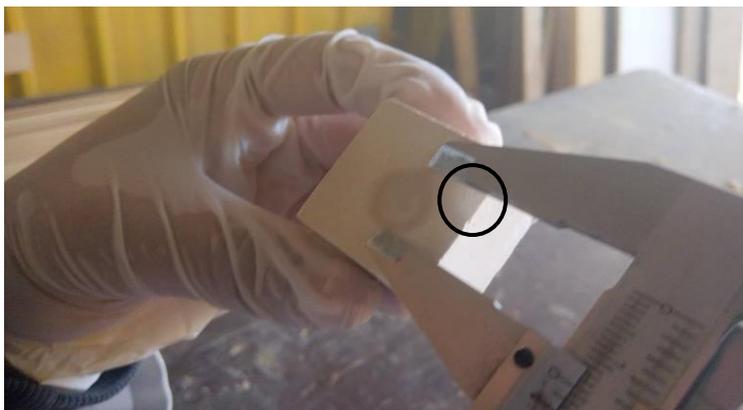
Fig. 11 Measurement of the diameter of the dispersed consolidation materials.

The consolidation process with Mirovski and Immersion methods were followed up and recorded the results Fig. (1-11), Table (1).

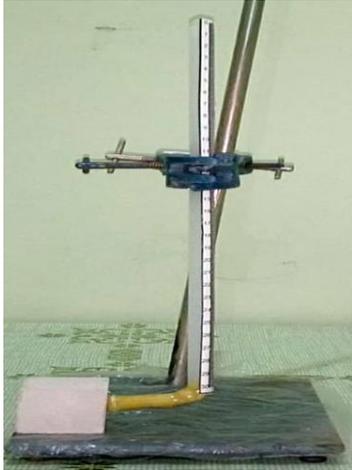
Fig.1 Showing the Meroviski consolidation process.

Two methods of reinforcement were used, the first was the Mirovski method[24], This method is based on the spread of the consolidation material within the impact in the semi-circular form, and the repetition of the application of previous operations can be strengthened large areas of the impact surface by the convergence and overlap of semi-circles, This method is based on the spread of the consolidation material within the impact in the semi-circular, the stone cube of the reinforcement material was followed up every hour and the results were recorded Fig.1-10, Tab.1, for consolidating cube stone with NANORESTORE, the consolidating process continued for 252 hours, where the cube continued to absorbed for the consolidating material up to 248 hours, and then the cube stopped from absorbing till four hours after that and the cube absorbed 50 mm of NANORESTORE, While the consolidating of Remmers KSE 300 E process continued for 23 hours, where the cube continued to absorb up to 19 hours, and then stopped about absorbing for four hours and the cube absorb 9 mm of Remmers KSE 300 E however the consolidating of SILRES BS 100 OH process continued for 100 hours, where the cube continued to absorb up to 98 hours, and then the cube stopped from absorbing for two hours and the cube absorbed 11.5 mm of SILRES BS 100 OH, while the process of consolidating stone cube did not succeed in with Paraloid B72 and Paraloid B44 materials and Paraloid B72 concentration 3% concentration Paraloid B44 concentration 3%, and Ca (OH)₂/polymer nanocomposites, as the acrylic polymers have blocked the sponge pores used in the tube nozzle, and when we measure the diameter of the dispersed treatment material Fig. 11, SILRES BS 100 OH achieved 27.5 mm, Remmers KSE 300 E achieved 24 mm and NANORESTORE achieved 18 but The process of consolidating stone, In the immersion method, the stone cube was left for 24 hours in the reinforcement material, Fig.2, Tab.1 and the result of reinforcement materials showed that the cube which treated with Nano restore absorbed 17.5 mm, and absorbed 10 mm from SILRES BS 100 OH and Remmers KSE 300 E, however, the stone cube absorbs 30 mm from Paraloid B72 concentration 3% but absorbed 20 mm from Paraloid B44 concentration 3%, and from Nanocomposite materials, the stone cube absorbed 20 mm from paraloid B72 concentration 3%), and Ca (OH)₂/polymer nanocomposites while the cube absorb 15 from Paraloid B44 concentration 3%, paraloid B44 concentration 3%), and Ca (OH)₂/polymer nanocomposites.
